Brief by Gilles Primeau, M.Eng., Pilot (private)

To the Standing Committee on Transport, Infrastructure and Communities (TRAN)

Regarding the subject being studied of the Aircraft Certification Process

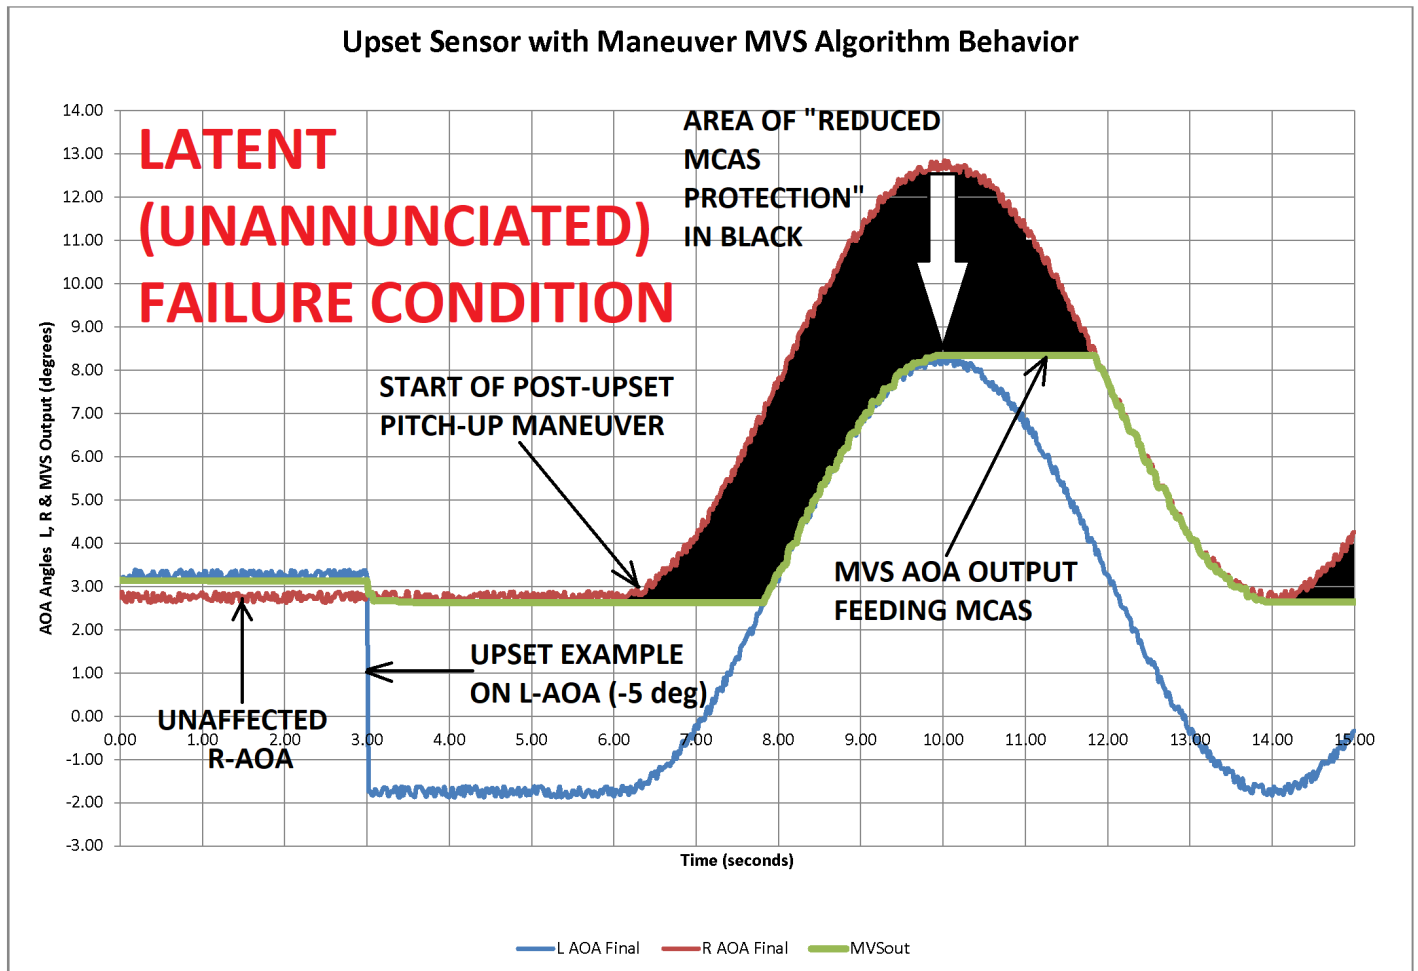
Upset Sensor with Maneuver MVS Algorithm Behavior

FAA NPRM documentation^(1, Att.3) described the *mid-value select* (MVS) algorithm which operates using 3 parameters: left AOA, right AOA, and MVS output, latter being the middle numerical value from those 3 choices, iteratively-computed. Very importantly, the MVS algorithm does not trigger a fault if the difference between the L&R AOA signals is less than 5.5°. The author developed a simulation of the MVS algorithm, with several adjustable parameters including independent random noise on each AOA source for representativeness. The scenario illustrated in the next figure highlights a potentially hazardous situation when a specific type of AOA upset is combined with a required crew maneuver:

Initially, both AOAs track each other normally and the MVS algorithm selects either the L or R AOA signal, both adequate. Postulate firstly that suddenly, as happened on ET302, one AOA suffers an upset (L-AOA in blue), but toward LOWER values, and by less than the MVS algorithm's 5.5° differential fault threshold. Due to the MVS algorithm logic, its output (green trace) will correctly switch to the unaffected other sensor (R-AOA in red). Postulate also secondly that the crew later has to make a sudden high amplitude pitch up maneuver (typically for collision avoidance); the MVS output will remain constant despite both AOAs rising, until the affected L-AOA reaches the same MVS output value, at which point the MVS output will switch to the signal from the affected L-AOA, thus becoming biased down by the magnitude of the L-AOA upset, thereby feeding the MCAS with a lowered activation threshold, delayed by a potentially critical amount of time to prevent an aerodynamic stall in this dynamic example. It's extremely important to consider the latent (or dormant, i.e. unannounced) nature of this failure condition, because the crew would be misled into believing the MCAS would intervene to avoid a stall if their collision avoidance maneuver was too aggressive (which tends to be the case for urgent maneuvers), since no MCAS fault would be posted to the crew to warn it to be careful. The upset could happen long before the flight, for instance due to the sensor being hit during ramp operations, and remain latent/dormant. Even simulator training can be misleading, unless this specific type of dormant upset could be injected by the simulation instructor, unnoticed by the crew, followed by creating obstacle avoidance conditions. This latent failure condition is real and undeniable. The dependable relief from it should in principle have to take into account statistical considerations of exposure time to the AOA sensor upset/failure probability, combined with the probability of the need for an aggressive collision avoidance maneuver. TCCA told the author that the MVS was reviewed by TCCA Engineering and critical cases evaluated by TCCA Flight Test in Boeing's Engineering Simulator, that these reviews and evaluations included Loss of MCAS with consideration for the MSV contribution, which led to the conclusion that the design was deemed acceptable. This conclusion, in the author's opinion, implies that the engineering analysis/evaluation and simulator

testing showed absolutely no adverse effect from the presence of the failure condition, and without quantified comparative results this is hard to accept; any quantified degradation in aircraft handling quality from a delayed MCAS intervention would have been expected to lead to consideration, in the author's experience, for a Certification Continued Maintenance Requirement (CCMR), intended to inspect and test the AOA sensors at a regular frequency pursuant to the failure condition probability analysis, to prevent any failure dormancy from exceeding the analysis' parameters.
